Manhole Inspection Summary

Manhole # S31S1_030MH

Insp Date: **2/18/08 9:33 AM**

Location Address: **3520 Spelman Road**

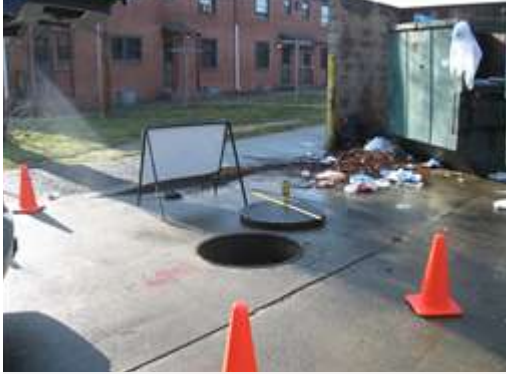
Location View

Comments **Manhole located by dumpster**

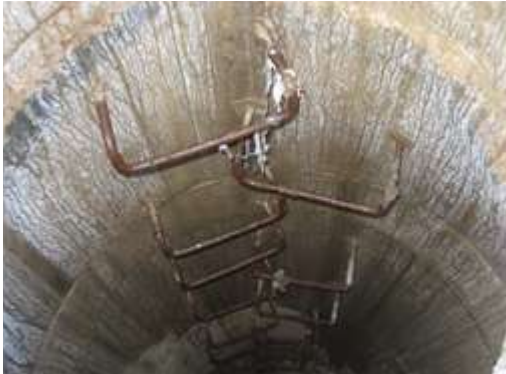
Steps Count: **13** Missing: **0** ☐ Corroded

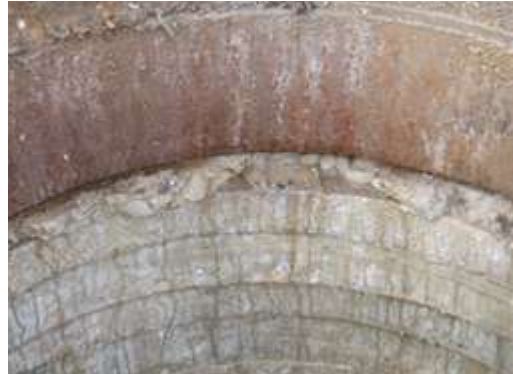
Defect 1

Infiltration: ☐ None ☐ Joint ☐ Cracks ☒ **Mortar** ☐ Roots ☐ Wall

Infiltration

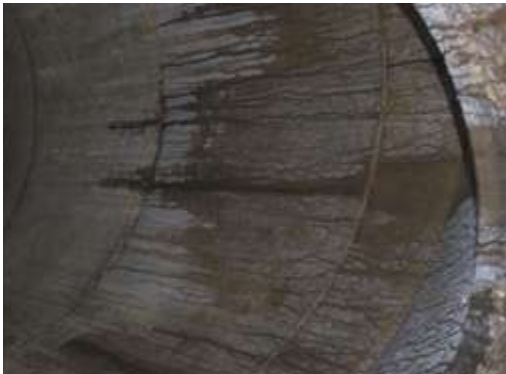
Defect 2

Infiltration: ☐ None ☐ Joint ☐ Cracks ☐ Mortar ☐ Roots ☒ **Wall**

Wall

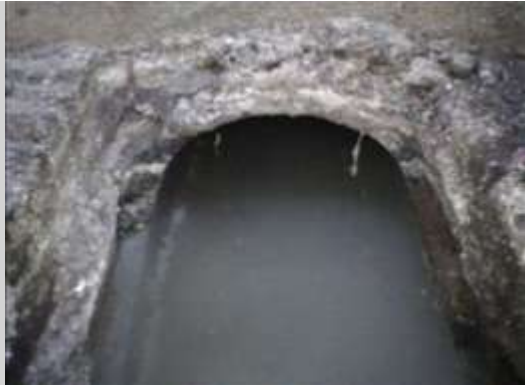
12 O'Clock Outflow

15 in. Circular Gravity Sewer
Pipe Out @ 12 O'Clock

Pipe Height: **16.8** (in.) Rod and Bar (Angled)
Pipe Material: **Clay** ☐ Pipe Lined
Invert Depth: **16.88** (ft.) Flow Characteristics: **Fast**
Deposits: ☒ None ☐ Mud ☐ Sludge ☐ Debris ☐ Grease
Silt Depth: (in.) Deposits Extent:
Infiltration: **None** Pipe Seal Cond: **Sound**

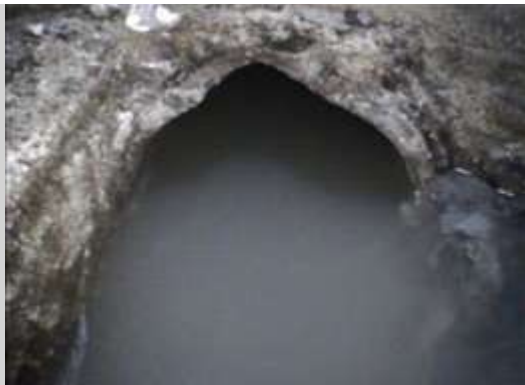
6 O'Clock Inflow

15 in. Circular Gravity Sewer
Pipe In @ 6 O'Clock

Pipe Height: **16.8** (in.) Rod and Bar (Angled)
Pipe Material: **Clay** ☐ Pipe Lined
Invert Depth: **16.82** (ft.) Flow Characteristics: **Fast**
Deposits: ☒ None ☐ Mud ☐ Sludge ☐ Debris ☐ Grease
Silt Depth: (in.) Deposits Extent:
Infiltration: **None** Pipe Seal Cond: **Cracked**

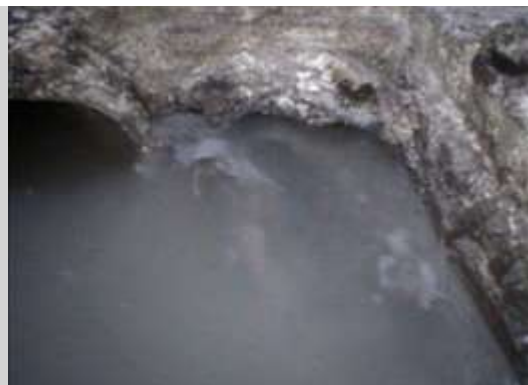
7 O'Clock Inflow

8 in. Circular Gravity Sewer

Pipe In @ 7 O'Clock

Infiltration: **None** Pipe Seal Cond: **Unknown**
